National Transportation Safety Board

Marine Accident Brief

Partial Sinking of Small Passenger Vessel *Spirit of Adventure*

Accident no.	DCA15LM008
Vessel name	<i>Spirit of Adventure</i>
Accident type	Partial sinking
Location	Seward Boat Harbor, Seward, Alaska 60°7.069' N, 149°26.053' W
Date	December 6, 2014
Time	Before dawn, about 1000 Alaska standard time (coordinated universal time – 9 hours)
Injuries	None
Property damage	Damage was estimated at \$2 million, resulting in a total loss of the vessel
Environmental damage	None
Weather	Calm winds, clear skies, visibility 10 nautical miles, water temperature 48°F, air temperature 32°F
Waterway information	Seward Boat Harbor is a protected harbor at the northern edge of Resurrection Bay, Gulf of Alaska

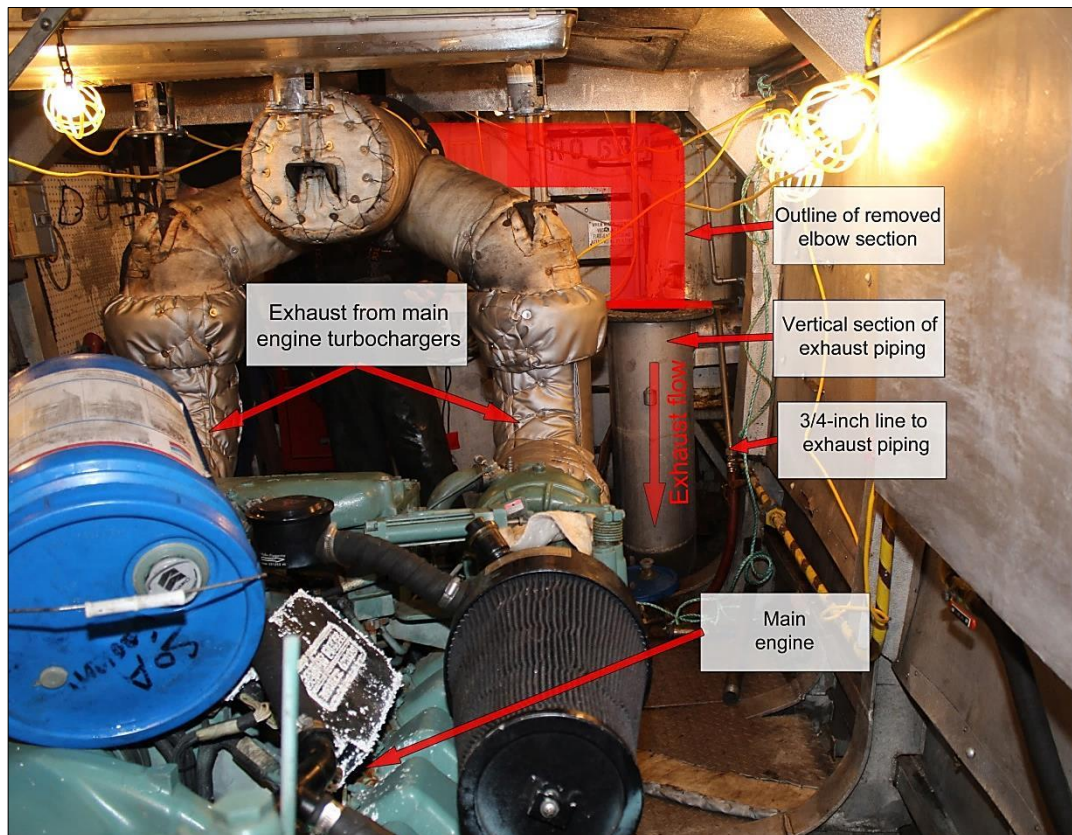
During mid-October 2014, company maintenance personnel removed a section of 10-inch-diameter, 90-degree elbow piping from the exhaust systems of both propulsion engines. The piping had developed leaks over a period of years that could no longer be repaired by welding or patching. The elbow sections were taken ashore to serve as patterns for the fabrication of new piping sections. When the exhaust piping elbows were removed, the flanged end of the vertical section of exhaust piping was open to the sea. The mechanics covered the opening with a plywood blank bolted to the flange but did not install a gasket to prevent leakage. Also, 3/4-inch-diameter cooling sea water lines to the exhaust piping were disconnected when the exhaust elbows were removed. The disconnected cooling sea water lines were not capped or plugged and were left loosely supported at an elevation above the waterline.

Photo of the port main engine room, looking aft. The red-shaded area indicates the approximate location of the elbow section removed from the main engine exhaust system piping. The opening at the top vertical section of the piping was covered by a bolted plywood blank.

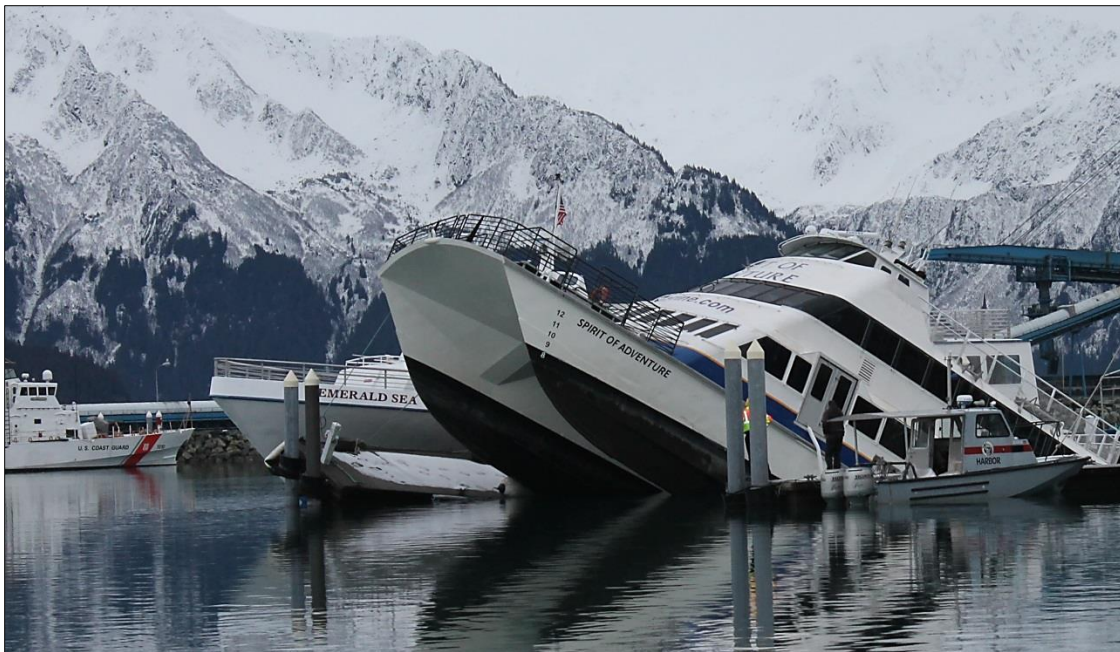
Shortly after dawn on December 6, 2014, about 1000, the captain of another vessel in the harbor observed the *Spirit of Adventure* partially sunk at its pier with its bow projecting from the water at a high angle of trim. The captain reported his observation to an employee at the marina harbor master's office, who then notified Major Marine Tours. By about 1030, staff from the operator and a local salvage company responded to the reported sinking to stabilize the situation, check for indications of water pollution, and begin salvaging the vessel.

Small passenger vessel *Spirit of Adventure* partially sunk at its winter layup pier, Seward Boat Harbor, Alaska. (Photo by Seward City News)

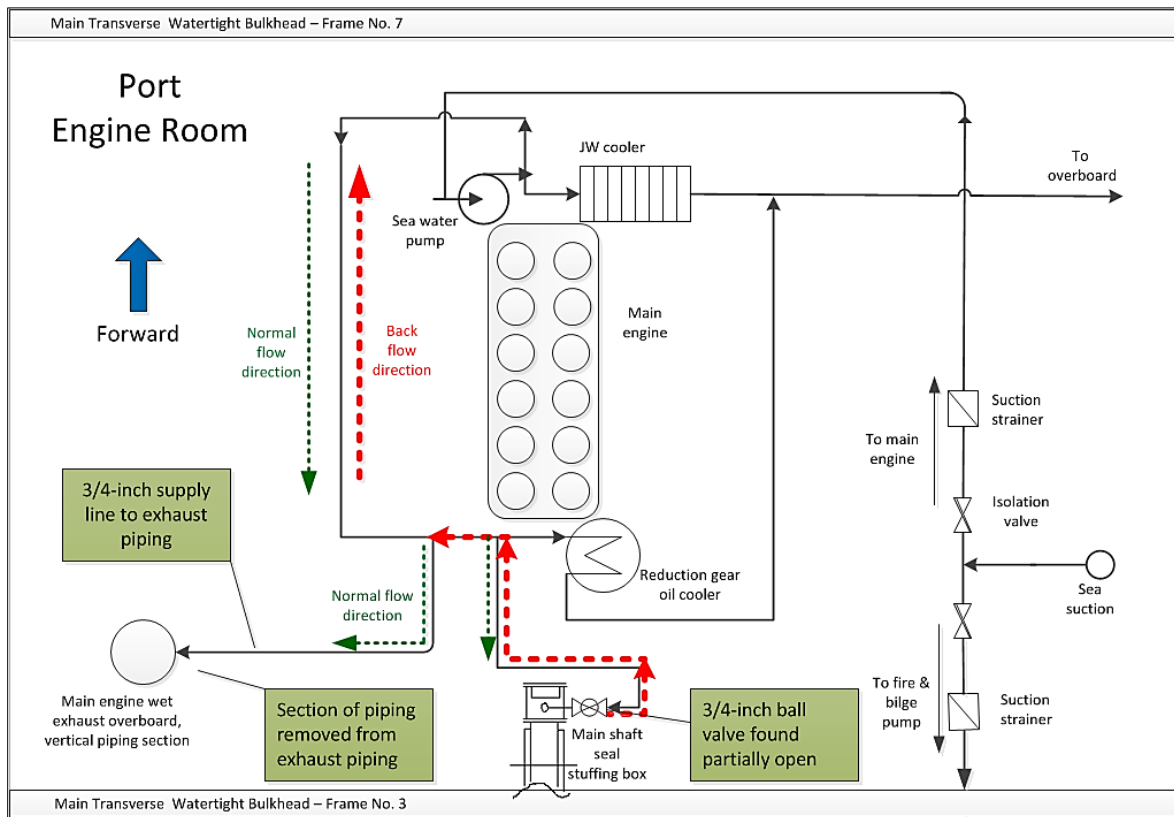
After the machinery spaces were dewatered, the responders checked the areas to determine the water's point of ingress. They found water flowing from the 3/4-inch-diameter sea water supply line to the port main engine exhaust system piping that had been disconnected along with the removal of the exhaust piping elbows. Additionally, the responders found the 3/4-inch-diameter ball valve at the shaft sealing water connection partially opened and assumed

that this partial opening was the point of ingress of the water flowing from the sea water supply line.

The fire/bilge pump overboard discharge valves in the port and starboard generator spaces were also found open, which would have allowed sea water to enter through the discharge openings in the vessel's hulls. The discharge openings were above the waterline at normal draft but would have become submerged as the draft increased from flooding in the port engine room. The increased draft would have allowed sea water to backflow into the generator spaces through drain plugs in the fire/bilge pumps, which were opened during the winter layup process.

Simplified schematic diagram of the sea water system in the port engine room showing the location of the shaft seal ball valve found partially open and removed piping connection to the main diesel engine exhaust system elbow. The normal water flow direction is shown by green arrows, and the backflow direction is shown by red arrows.

In addition, the operator did not have a lock-out/tag-out policy, which is generally a component of a formal safety system for vessels. A lock-out/tag-out policy could be used to protect machinery spaces from flooding by preventing the inadvertent opening of sea valves. Such a policy might have prevented the inadvertent opening of the shaft seal cooling water ball valve, the likely initiating event that caused the vessel to partially sink.

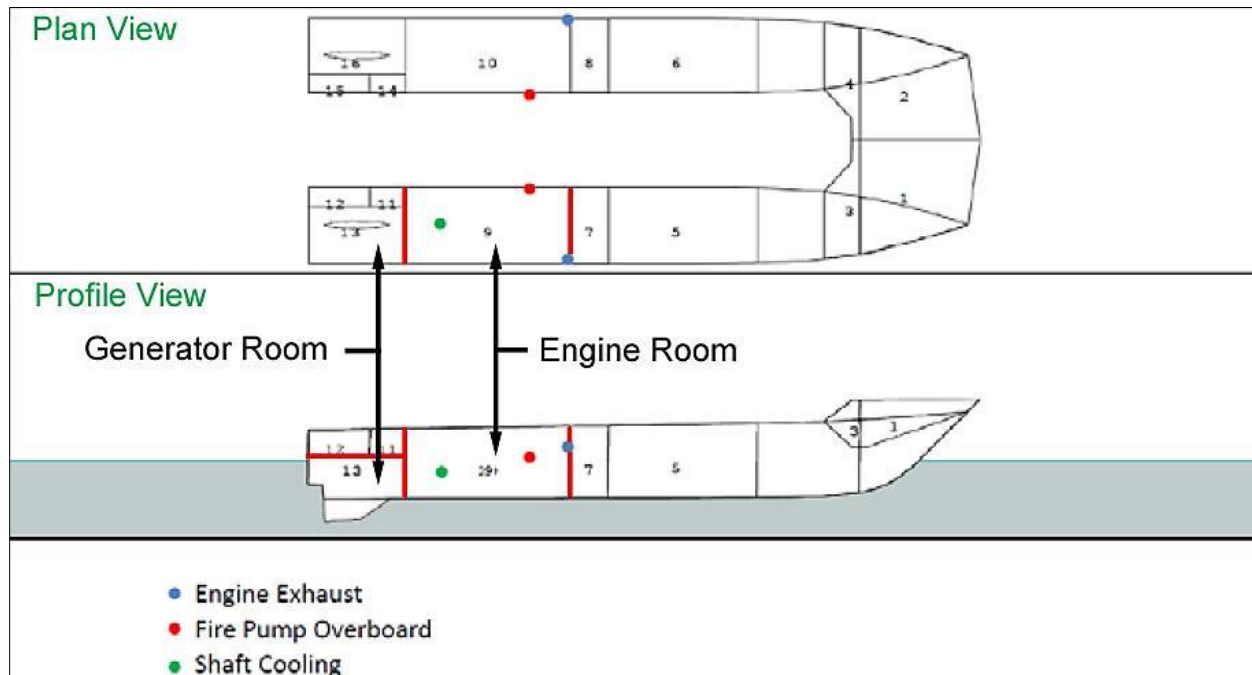
According to the 1999 Coast Guard vessel stability letter for the *Spirit of Adventure*, calculations indicated that the vessel would remain afloat with any one major watertight compartment flooded (one compartment subdivision). After the accident, the Coast Guard performed a stability analysis to evaluate the flooding scenario indicated by the sea water system conditions found in the vessel after it was salvaged. The Coast Guard analysis indicated that, when 20 percent of the port engine room was flooded by the disconnected 3/4-inch-diameter cooling line to the main engine exhaust, the port fire/bilge pump discharge opening became submerged, and flooding of the port generator space occurred. Further flooding in these port-side spaces resulted in subsequent flooding of the starboard machinery spaces, beginning in the generator room and continuing through the side fire/ballast pump discharge opening. The analysis also indicated that the vessel would sink with the flooding scenario indicated by the conditions found after the vessel was salvaged.

Plan and profile views of the *Spirit of Adventure* showing the arrangement of machinery spaces and locations of downflooding points. (Drawing from Coast Guard stability analysis)
